**SITE INVESTIGATION
REPORT FOR IRP SITES
NO. 25 AND NO. 26**

**148th FIGHTER WING
MINNESOTA AIR NATIONAL GUARD
DULUTH AIR NATIONAL GUARD BASE
DULUTH, MINNESOTA**

JUNE 1996

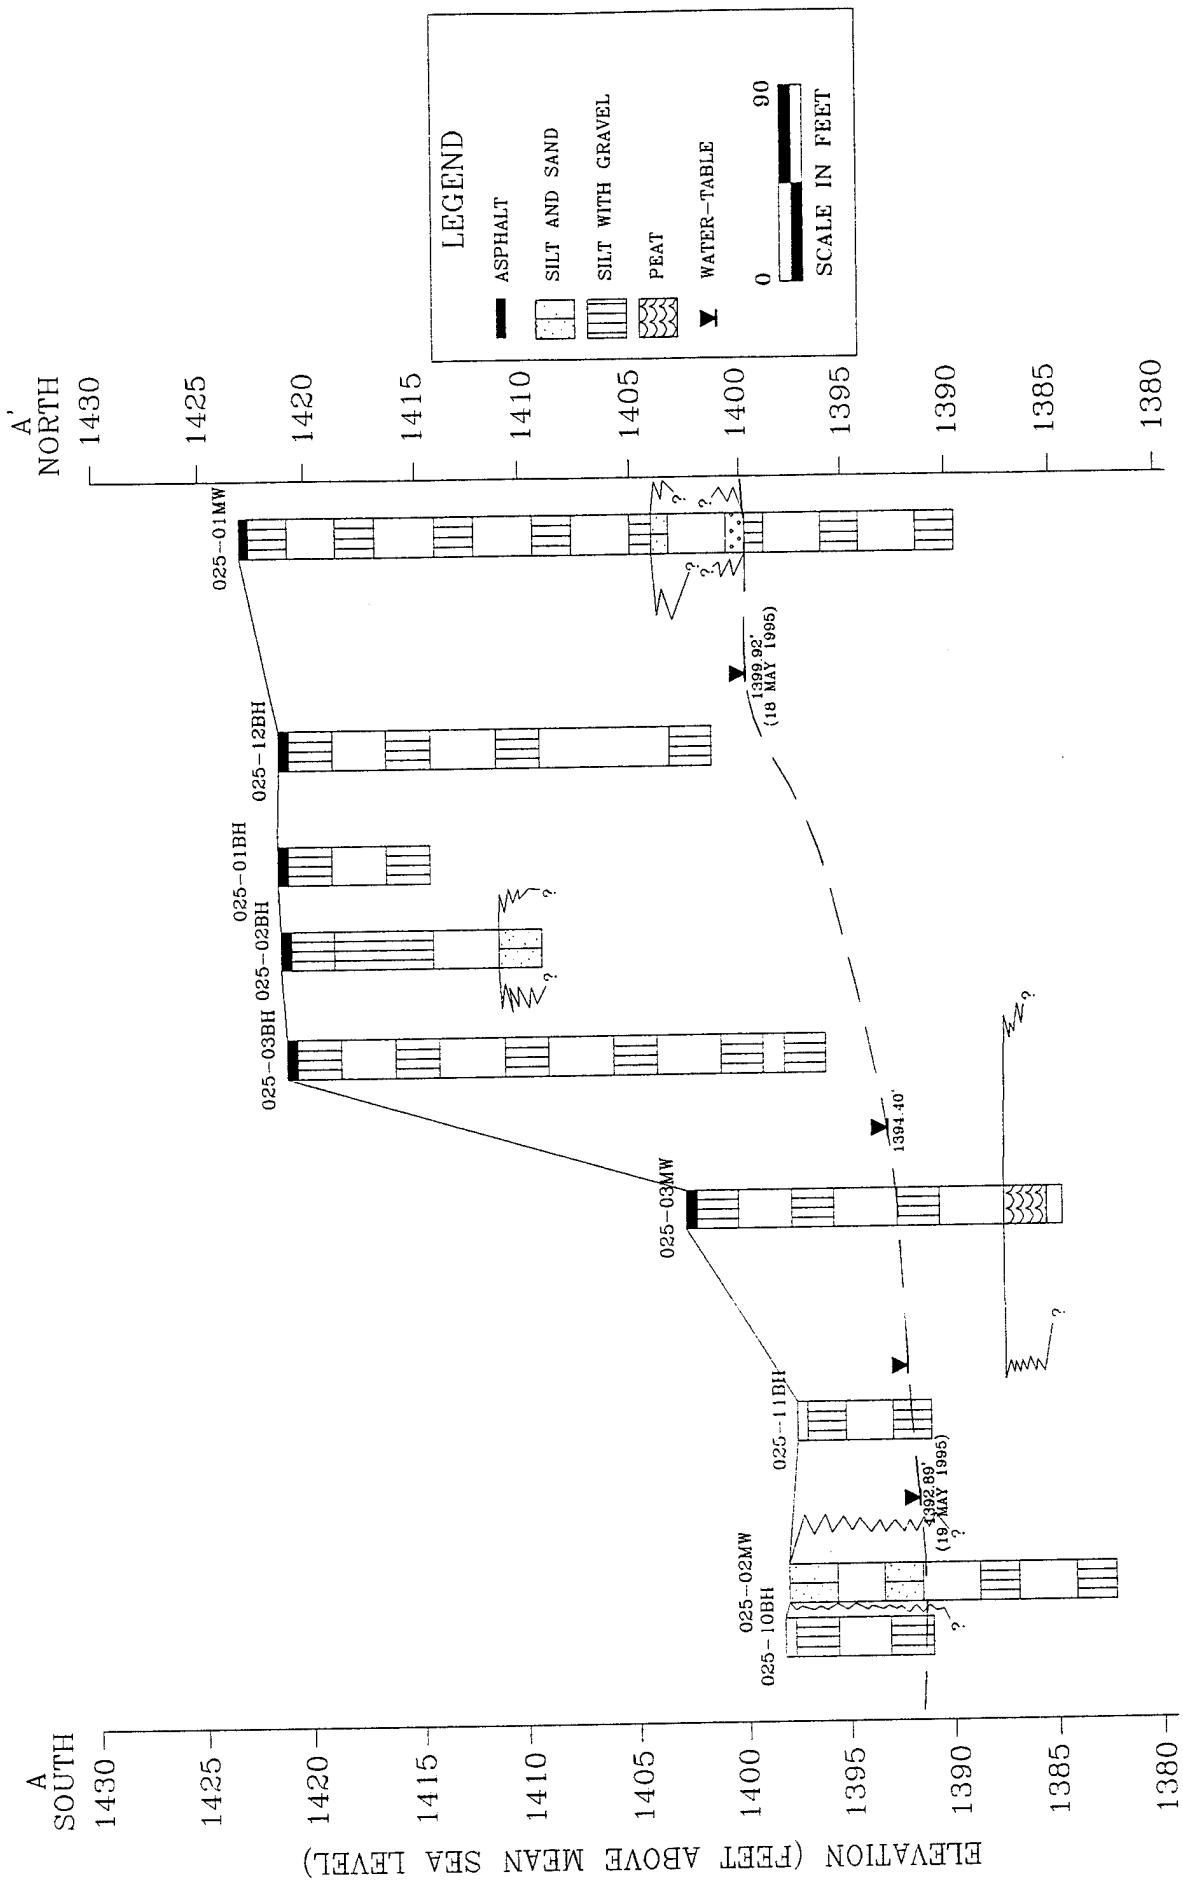
FIGURE 5.2

HYDROGEOLOGIC CROSS-SECTION A-A'
IRP SITE NO.25
Duluth Air National Guard Base
Duluth, Minnesota

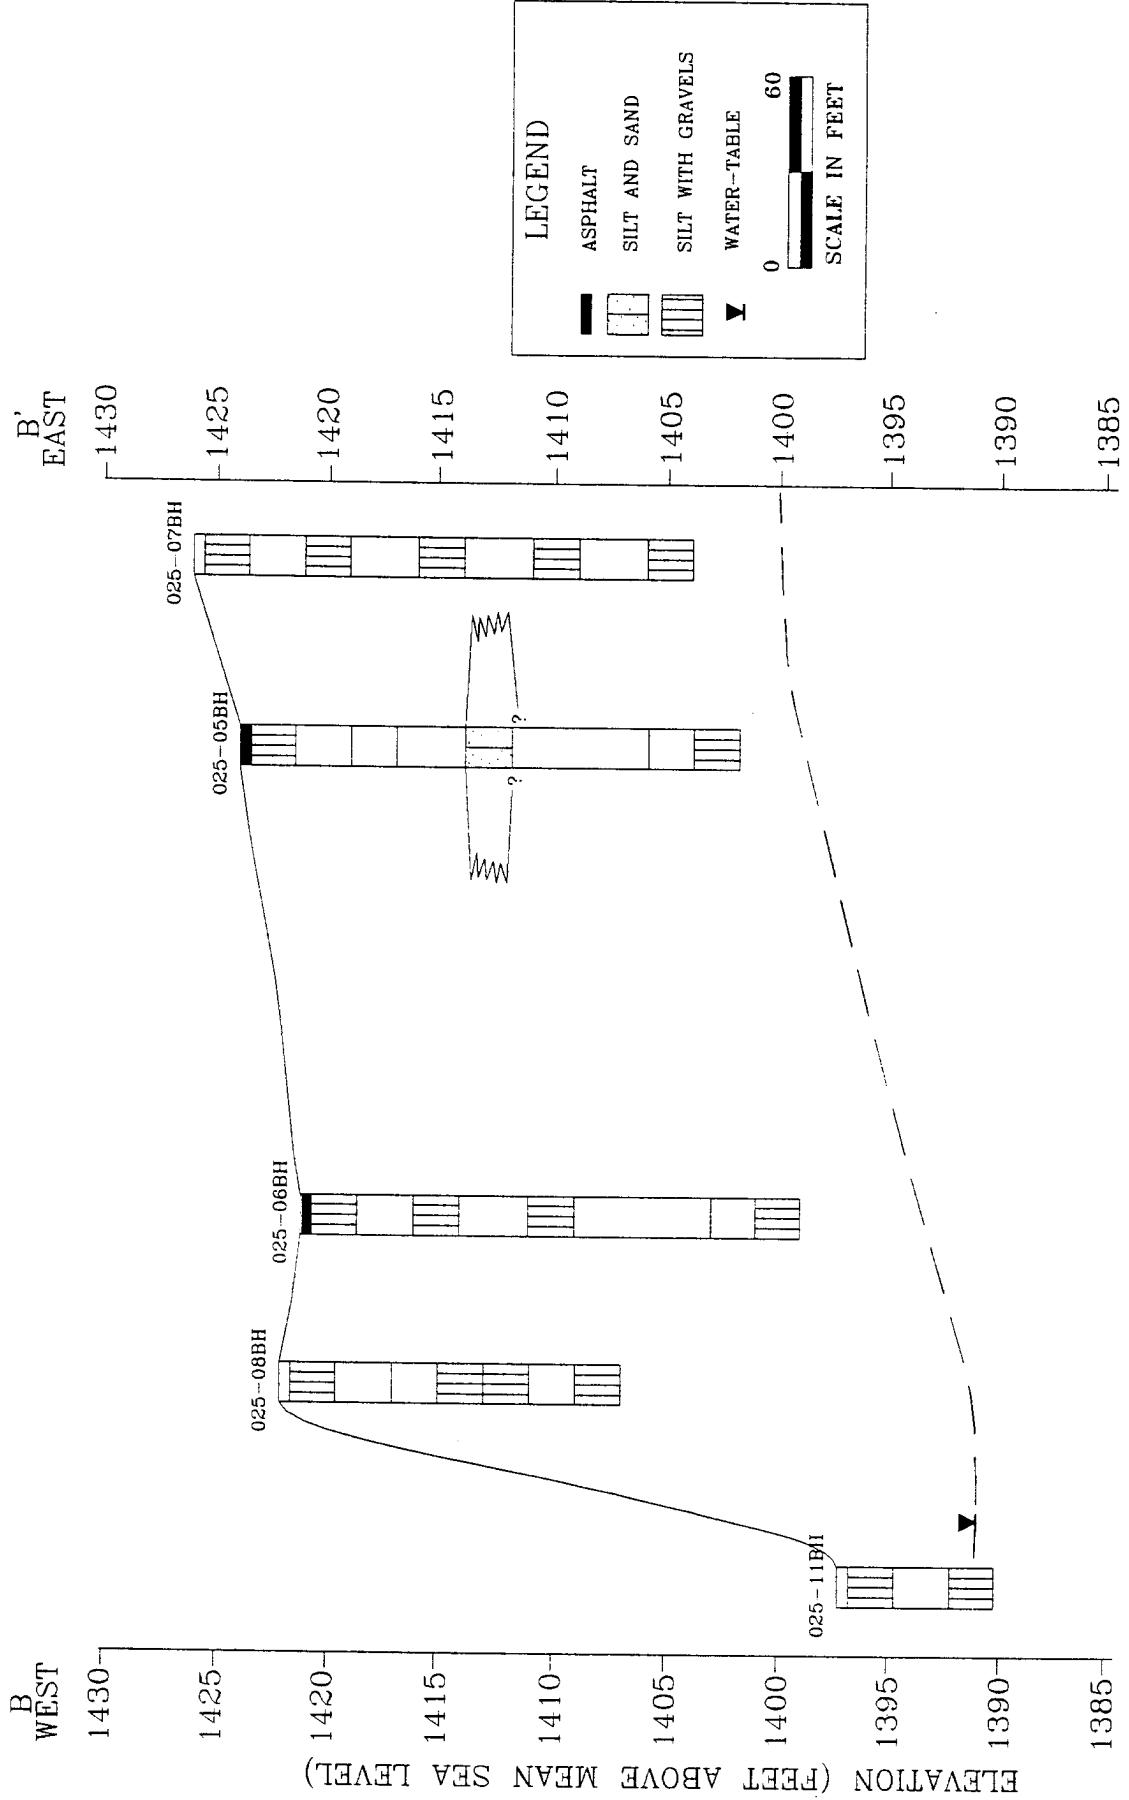
FIGURE 5.3

HYDROGEOLOGIC CROSS-SECTION B-B'
IRP SITE NO.25
Duluth Air National Guard Base
Duluth, Minnesota

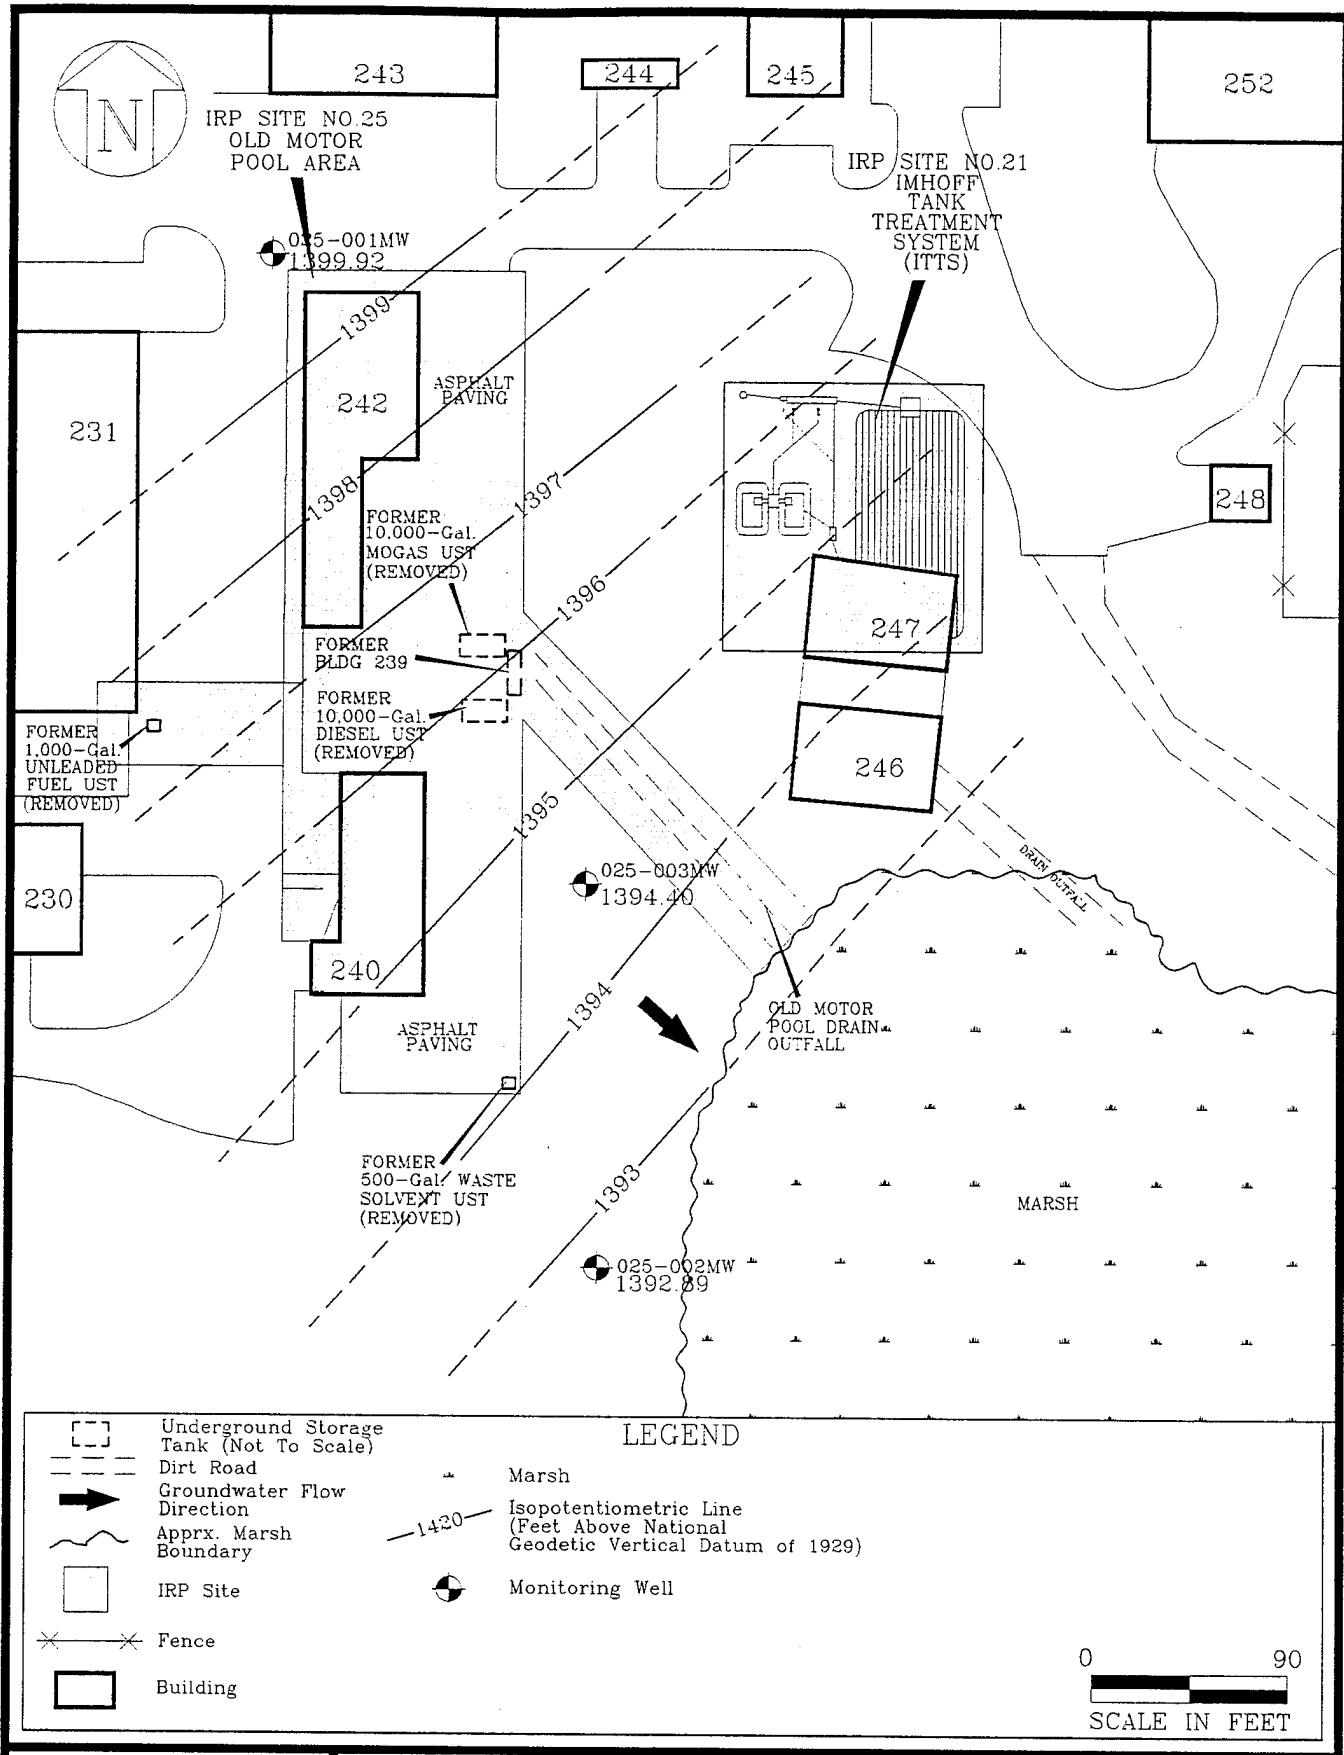
FIGURE 5.5

The potentiometric surface map is presented as Figure 5.5. The direction to groundwater movement at IRP Site No. 25 is to the southeast. The average I in the vicinity of IRP Site No. 25 was calculated to be 0.02 feet per feet (ft/ft), based on information from the potentiometric surface map.

GROUNDWATER POTENTIOMETRIC
SURFACE MAP 18 AND 19 MAY 1995
AT IRP SITE NO.25
Duluth Air National Guard Base
Duluth, Minnesota

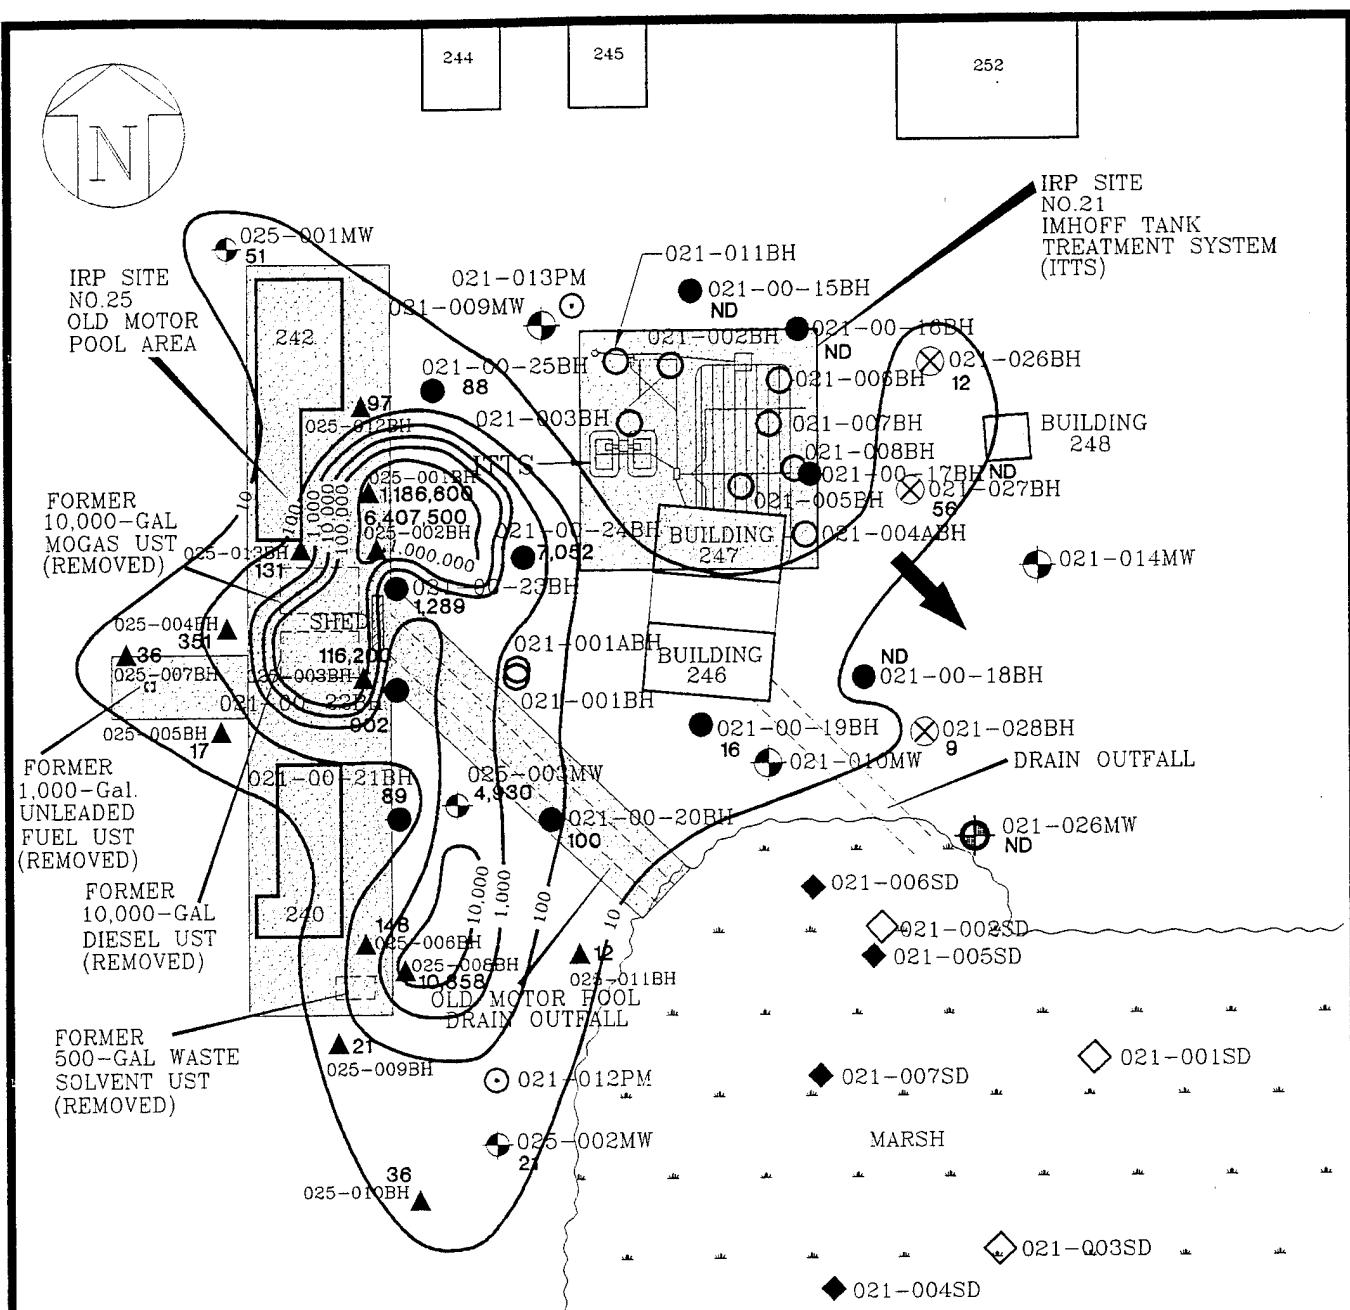
Benzene, toluene, ethylbenzene, m,p-xylene, and o-xylene were detected, with maximum concentrations of 5,800 parts per million (ppm), 263 ppm, 25.5 ppm, 205 ppm, and 114 ppm, respectively, in the soil sample collected from soil boring 025-002BH. The field GC screening results are presented in Appendix B.

GC SCREENING RESULTS
AT IRP SITES NO. 21 AND NO. 25
Duluth Air National Guard Base
Duluth, Minnesota

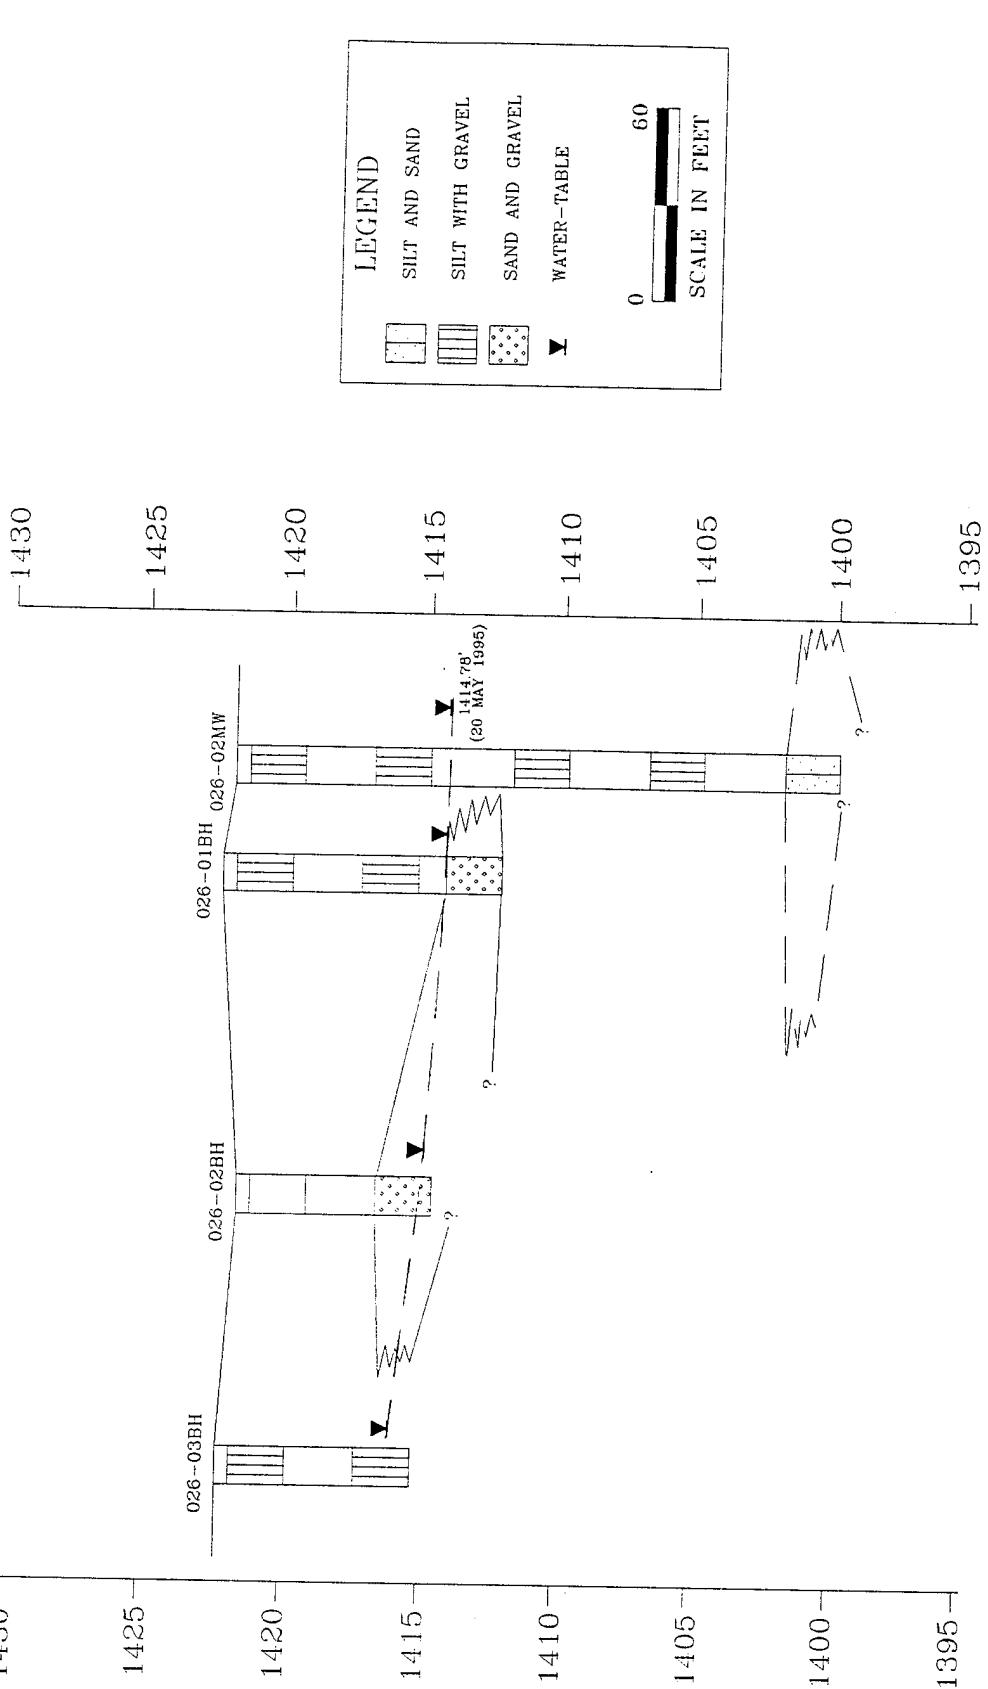
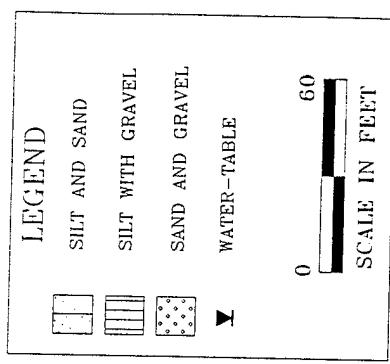
FIGURE 5.11
DULUTH\A-ACROSS

HYDROGEOLOGIC CROSS-SECTION A-A'
IRP SITE NO.26

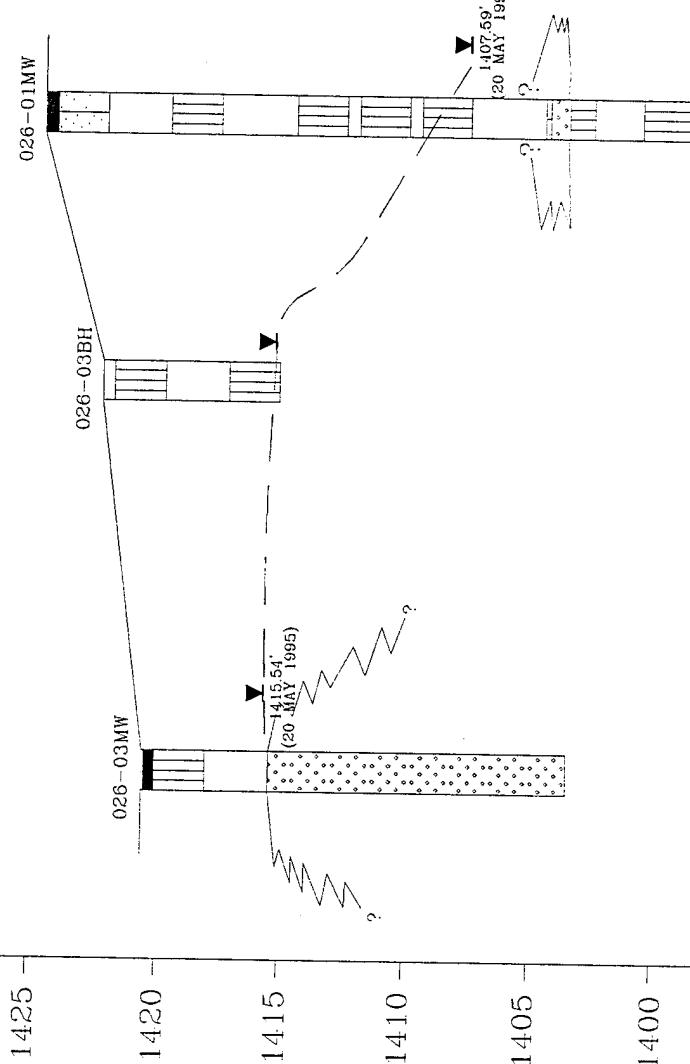
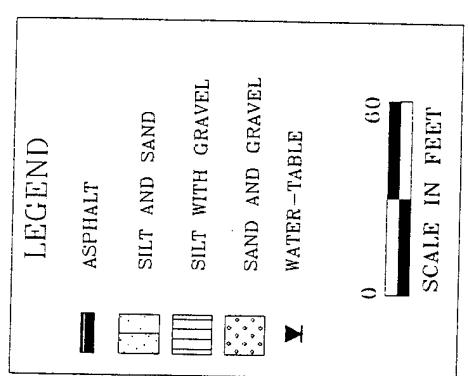
FIGURE 5.13

HYDROGEOLOGIC CROSS-SECTION C-C'
IRP SITE NO.26
Duluth Air National Guard Base
Duluth, Minnesota
